PRELIMINARY FINDINGS OF THE VISUAL ASSESSMENT

Pruitt Avenue Bridge Over Pruitt Creek

Prepared for Zero Waste Sonoma

November 2023

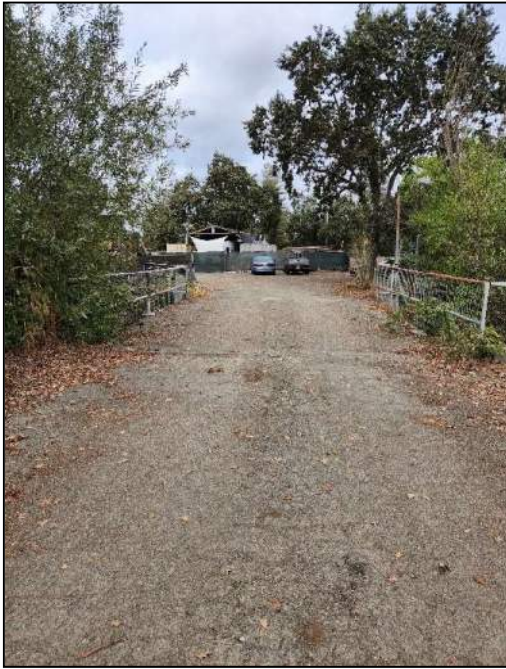
Fig. 1: North view of bridge from approach

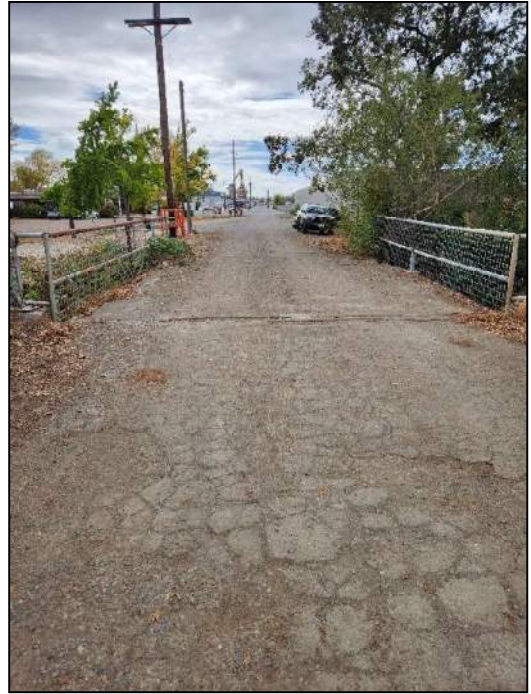
Fig 2: South view of bridge from approach

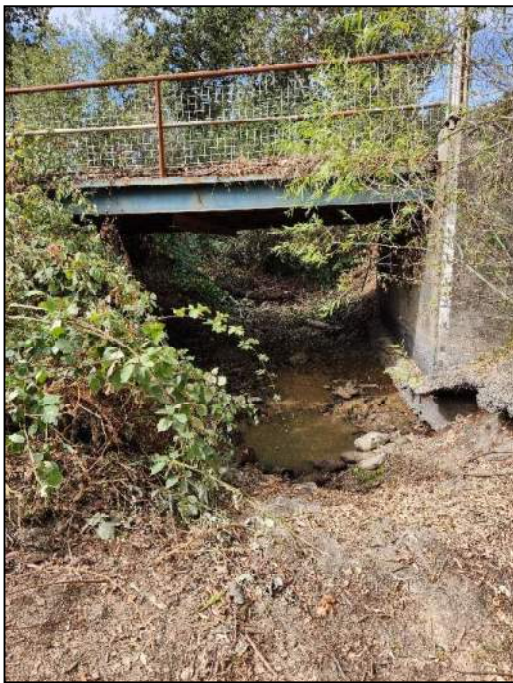
Fig 3: East view of bridge from creek bed

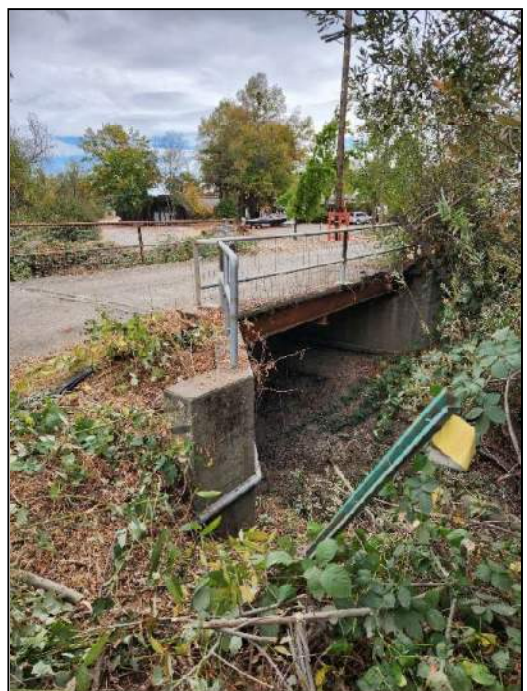
Fig 4: West view of bridge from roadway

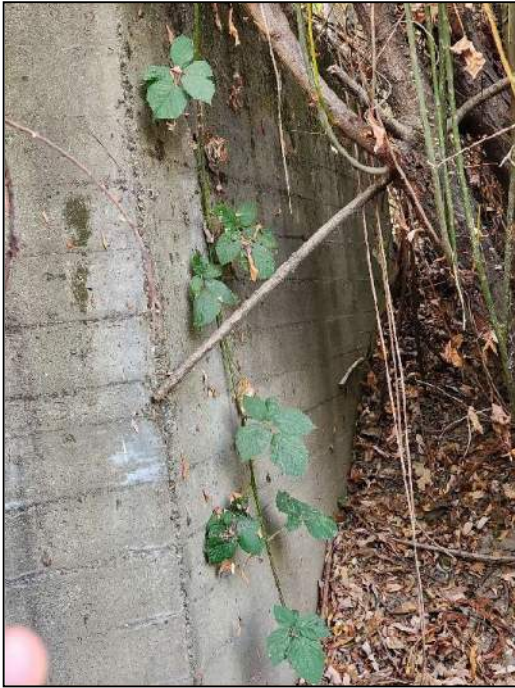
Fig 5: Southwest wingwall

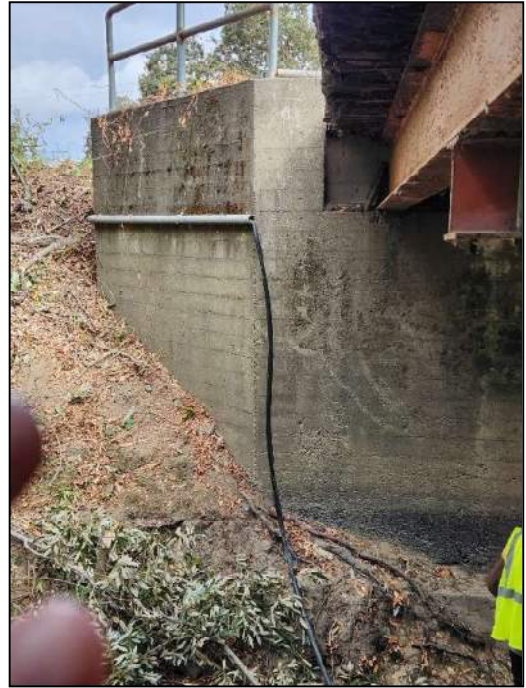
There is a steel conduit on the west side of the North abutment that is carrying a insulated cable. This cable exits the conduit and travels diagonally under the bridge to the east side of the South abutment where it transitions to underground. The cable lays on the creek bed under the bridge.

The owner and purpose of this cable was not evident. With the cable laying within the channel bed and across the full width of the channel, there is substantial risk for debris catching on the cable and obstructing the creek flow or breaking the cable. The cable should be relocated or removed based on coordination with the cable owner.

Fig 6: Northwest wingwall with metal conduit and cable

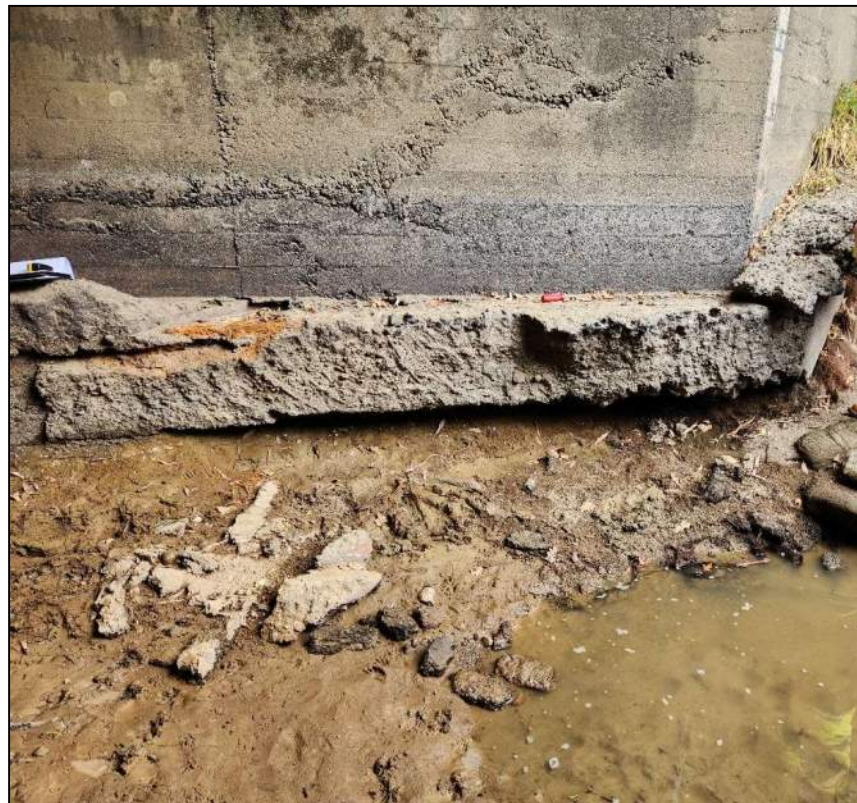
- Significant scour and undermining at the North abutment. This undermining appears to have resulted primarily from lateral migration of the creek towards the north abutment. Based on this preliminary assessment, it appears the bridge would be classified as Scour Critical, meaning that future high-flow storm events could result in further undermining, reducing the stability of the abutment and potentially could result in failure.

Fig 7: North Abutment Foundation

- Bridge scour and undermining. Regulatory agencies typically limit the extent of any new concrete or other unnatural materials placed within the creek bed and banks, and typically require mitigation for this loss of natural creek bed and banks. Mitigation may include requirements to improve a similar area of creek bank close to the site. Remedial work to reduce the potential for scour could include installation of additional rock riprap, vegetated rock riprap, articulated concrete mats or similar erosion-resistant materials in the creek. Hydrology and hydraulic analysis are required to determine design requirements for this scour mitigation, including the extent of the required scour mitigation and the rock sizing. In some cases, long term scour mitigation is not feasible due to those requirements, and bridge replacement may be required with new foundations either located outside of scour areas or supported on deep foundations that extend below the depth of potential scour. It may be feasible to install rock riprap or other materials to reduce the potential for scour in smaller and more frequent high-flow storm events.

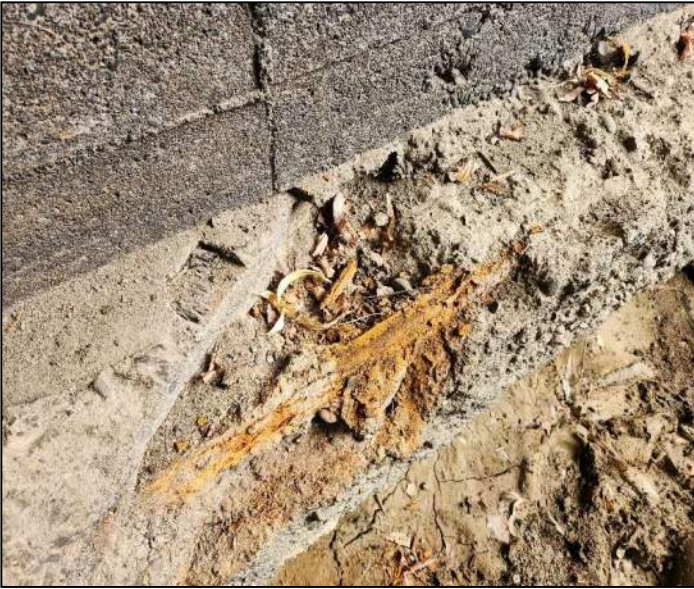
- Localized concrete failure and rebar corrosion in North abutment foundation. This appears to be a localized condition in two areas of the footing approximately 2' long and may result from inadequate concrete thickness over the steel reinforcing resulting in localized corrosion of individual reinforcement bars.

Fig 8: Localized concrete failure and rebar corrosion

- Abutment footing concrete repairs. This repair would consist of localized removal of deteriorated concrete and patching with proprietary repair products. This is a standard concrete repair method that would be performed within jurisdictional areas.

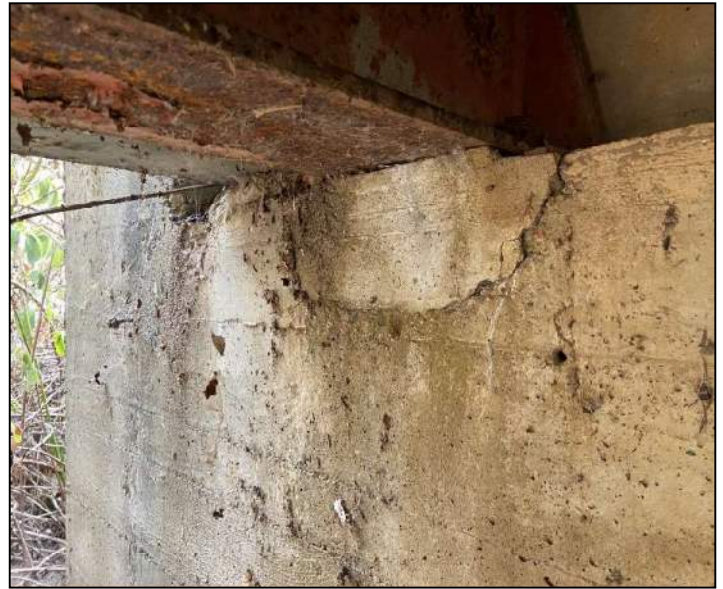
Fig 9: "Intact" spalling at South abutment bearing

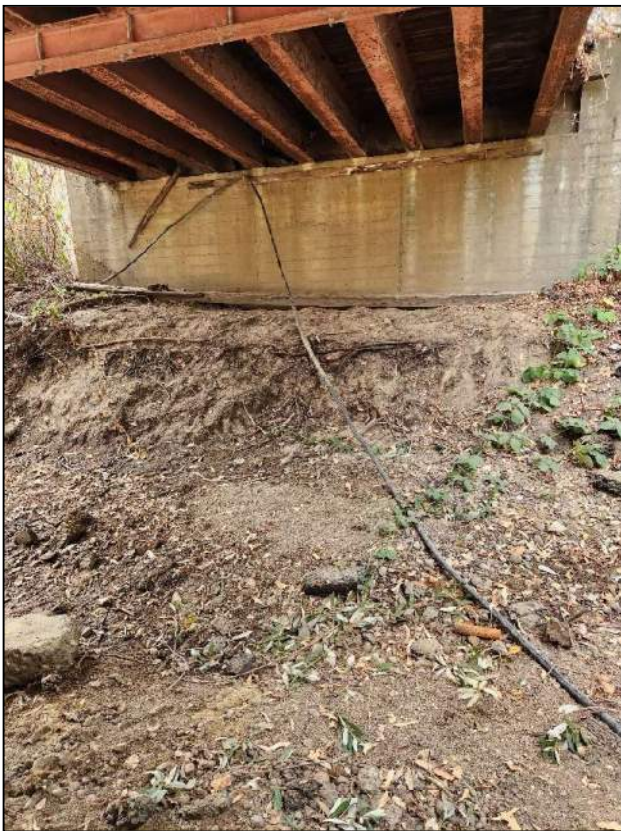
Fig 10: Unknown black cable disappearing underground at South abutment.

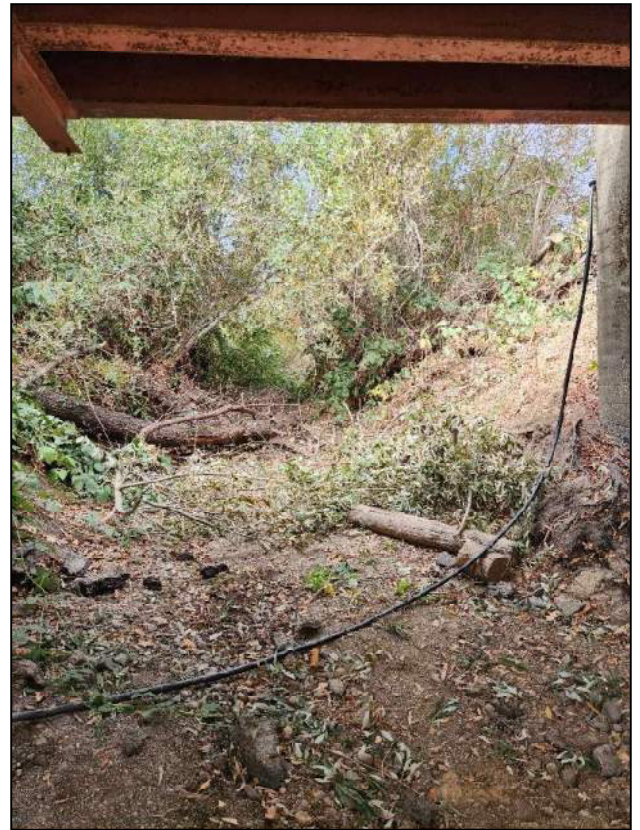
- The existing cable laying within the channel bed and across the full width of the channel creates a substantial risk for debris catching on the cable and obstructing the creek flow or breaking the cable. The cable should be relocated or removed based on coordination with the cable owner.

Fig 11: Unknown black cable running under the bridge from the North abutment.

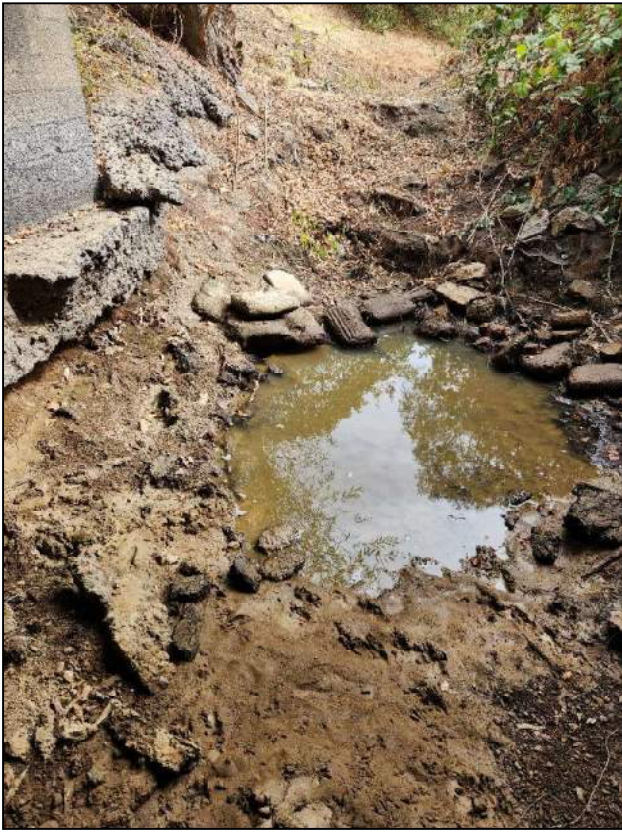
Fig 12: Sacked Concrete in creek bed

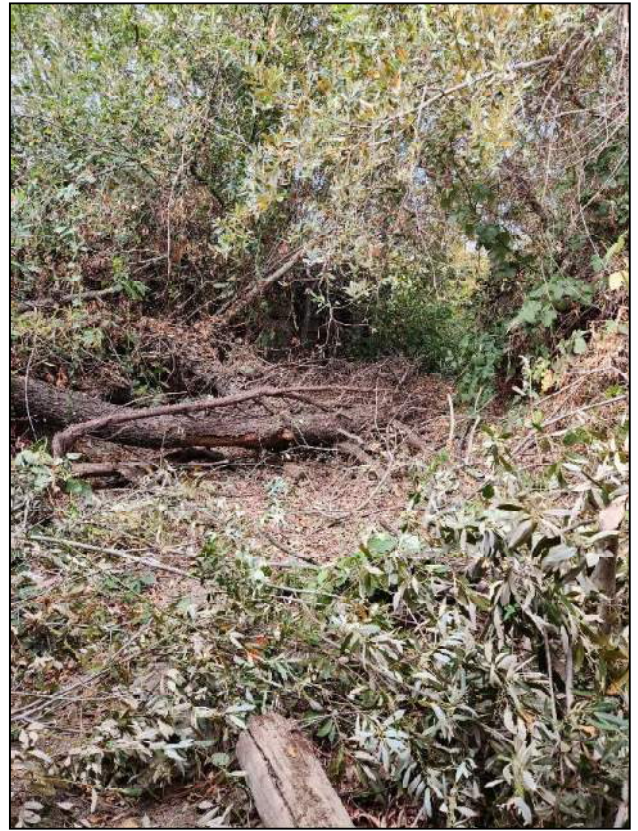
Fig 13: Tree trunk and debris downstream within channel

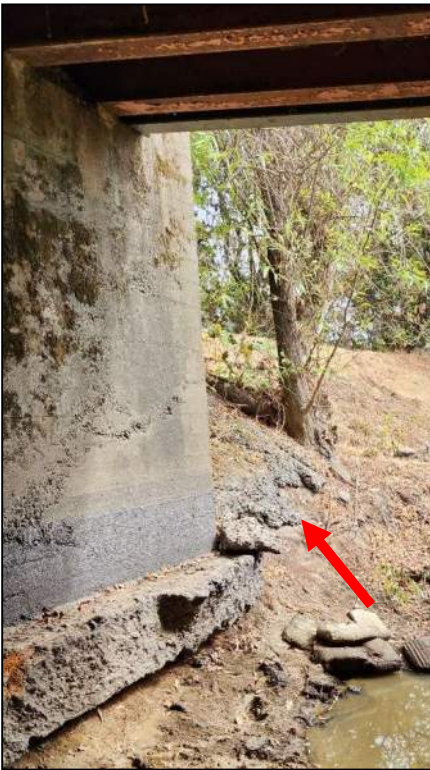
Fig 14: Asphalt that was used to try to stabilize North abutment.

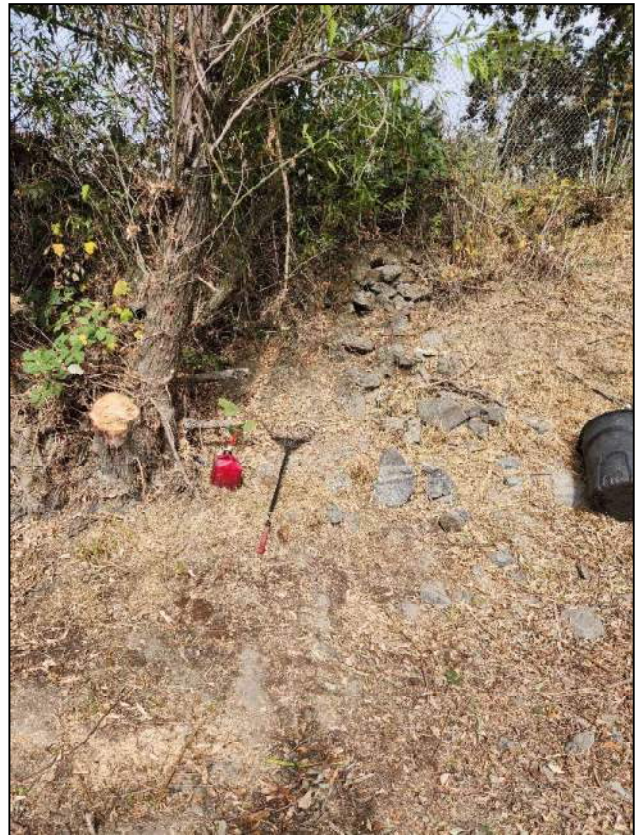
Fig 15: RSP on Northeast side of bridge

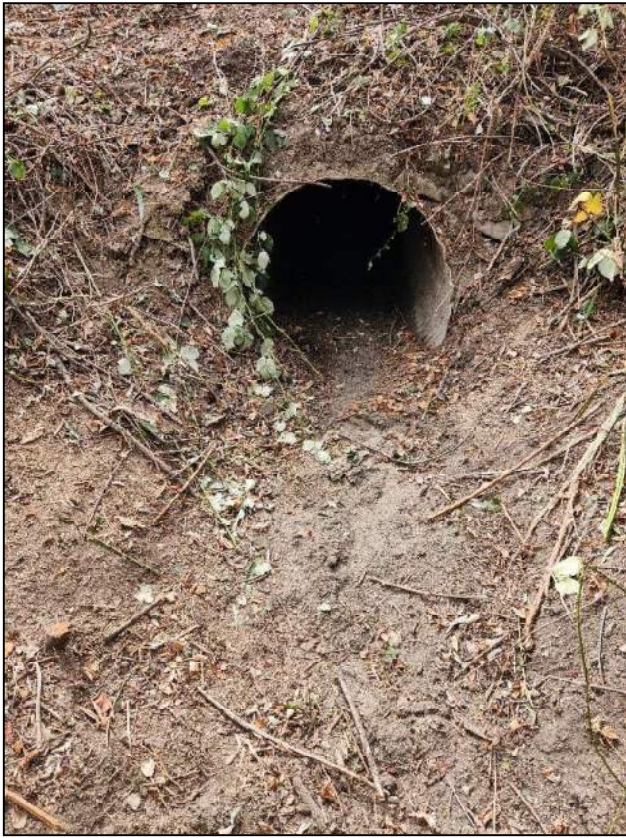
Fig 16: 42" CMP upstream from bridge

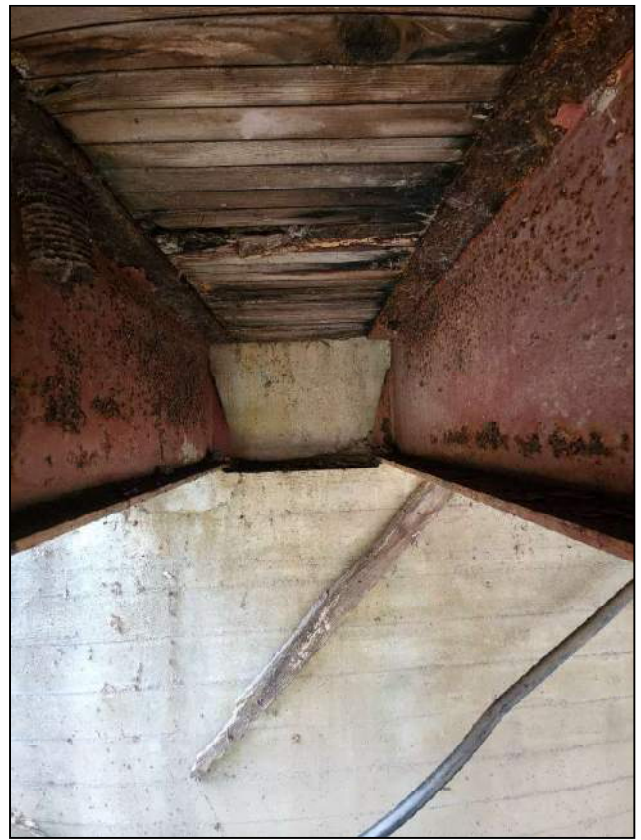
Fig 17: Broken timber decking facing South abutment

- Decking replacement. This would consist of removing the existing timber and asphalt and replacing “in kind” with similar new materials. Pressure-treated timber could be considered to extend the effective life of the timber, although may be prohibited by permit requirements. Additional waterproof flashings could be installed along the ends and edges of the bridge to extend the effective life of the new timber. This work would be over jurisdictional areas and would require a containment system to be installed under the bridge to prevent debris from entering the creek.

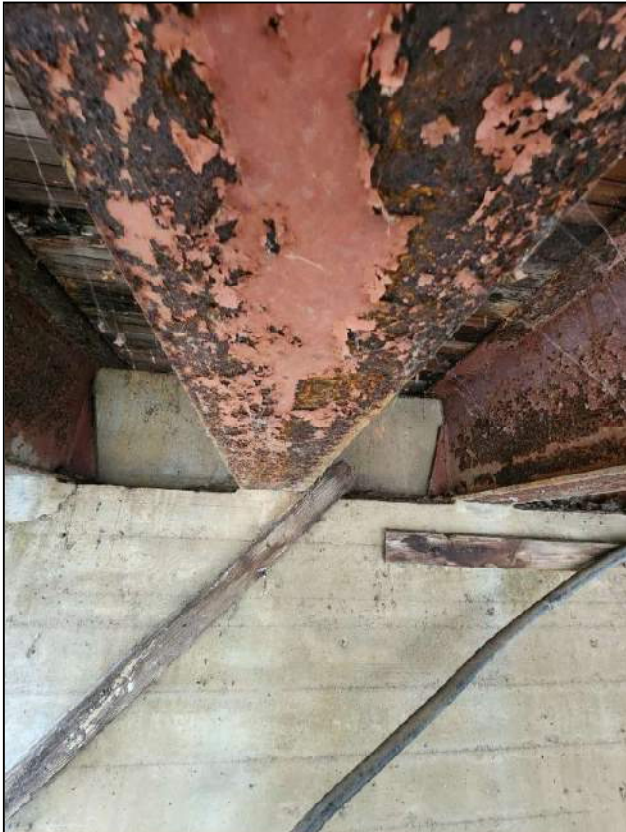
Fig 18: Paint peeling off from steel girders

- Re-painting. Due to the extent of paint failure, full repainting is recommended. This would consist of testing of the existing paint to identify any hazards, including lead, installation of a temporary containment system to prevent debris from falling into the creek, removal of the existing paint and surface protection and applying prime coats and finish coats. This work would be over the jurisdictional areas. Ideally this work would be completed in conjunction with deck replacement so the top surface of the beams can be re-painted and access to the beams is improved.

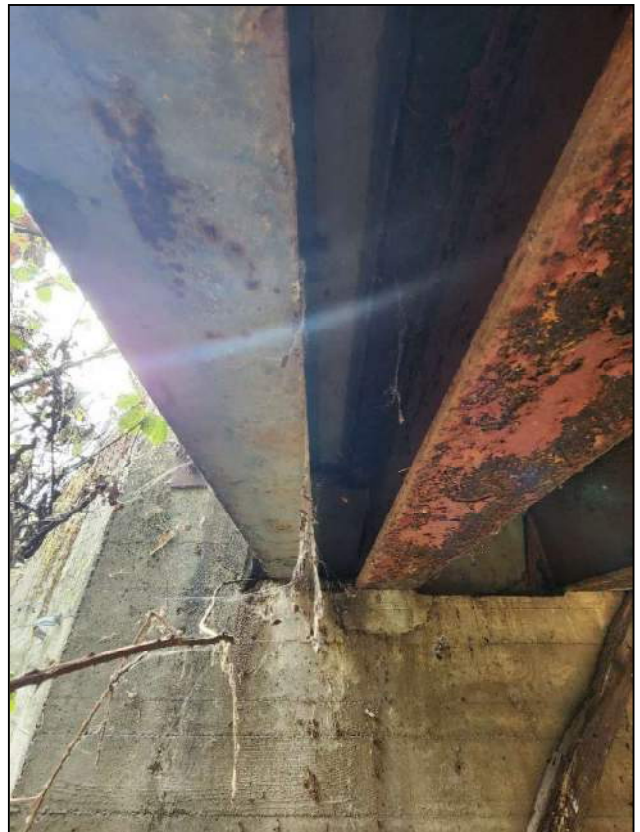
Fig 19: New edge girder added for railing

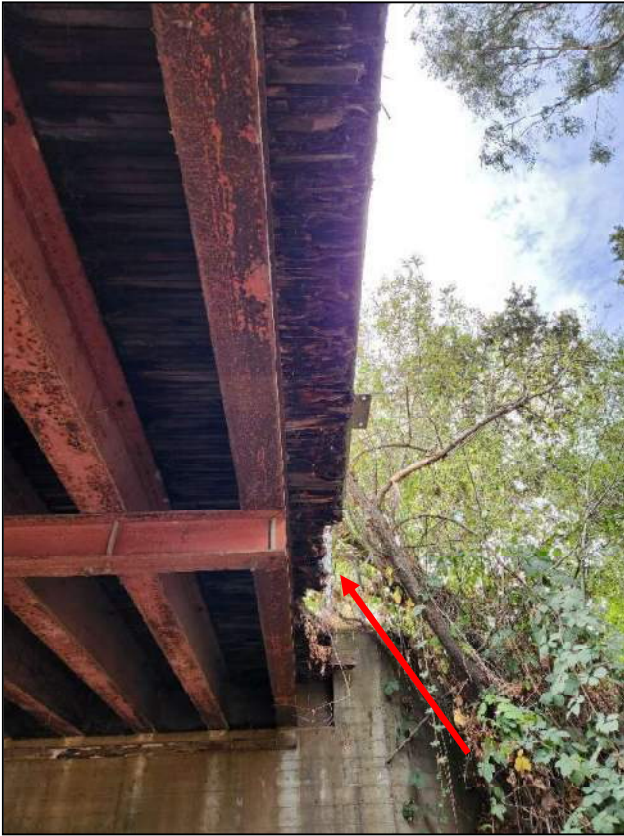
Fig 20: Timber decking deterioration on Southwest edge of bridge

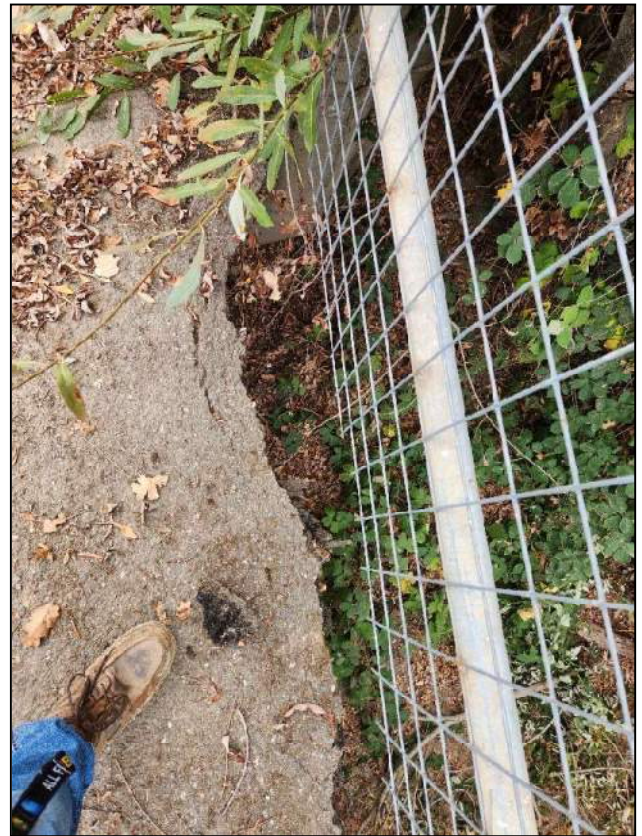
Fig 21: Asphalt crumbling on Southwest edge of bridge

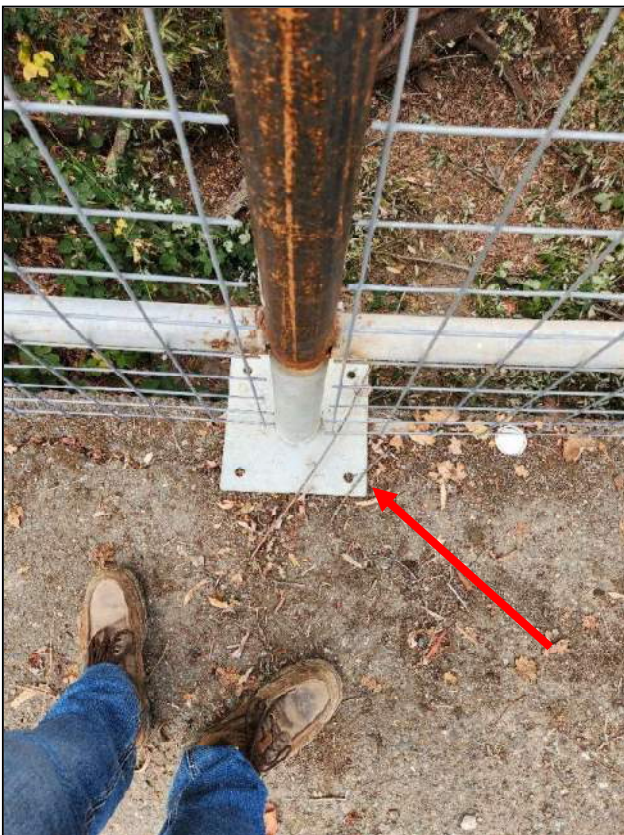
Fig 22: Post not attached to any part of deck

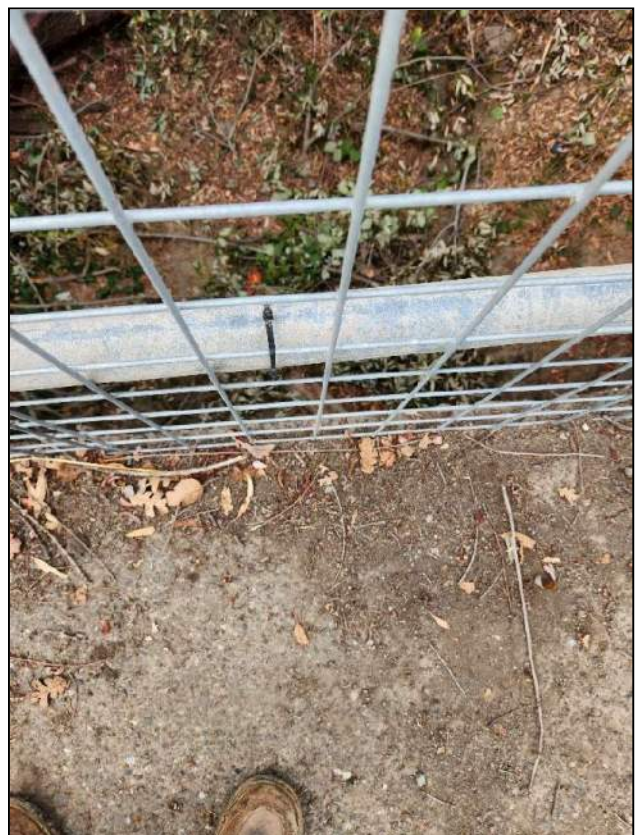
Fig 23: Zipties holding mesh to tube railing

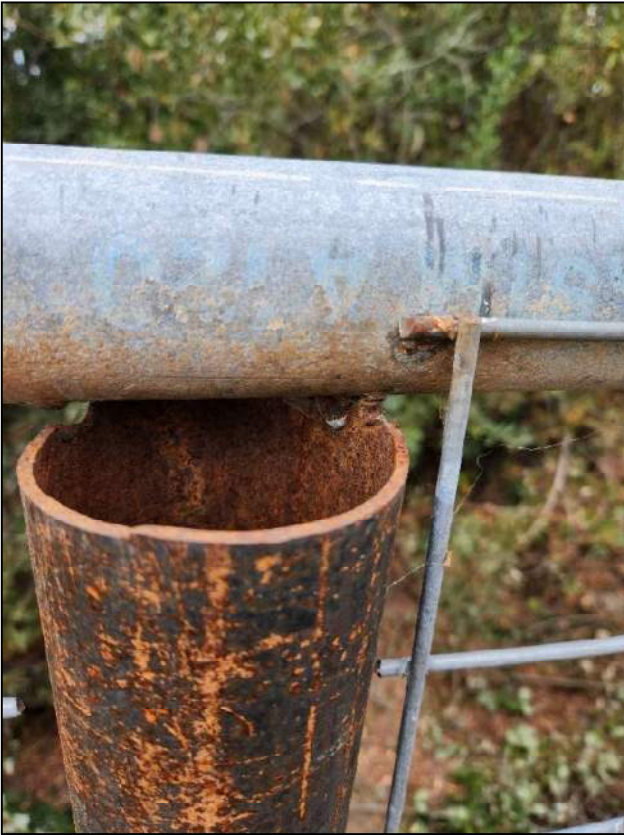
Fig 24: Tack welds holding railing together

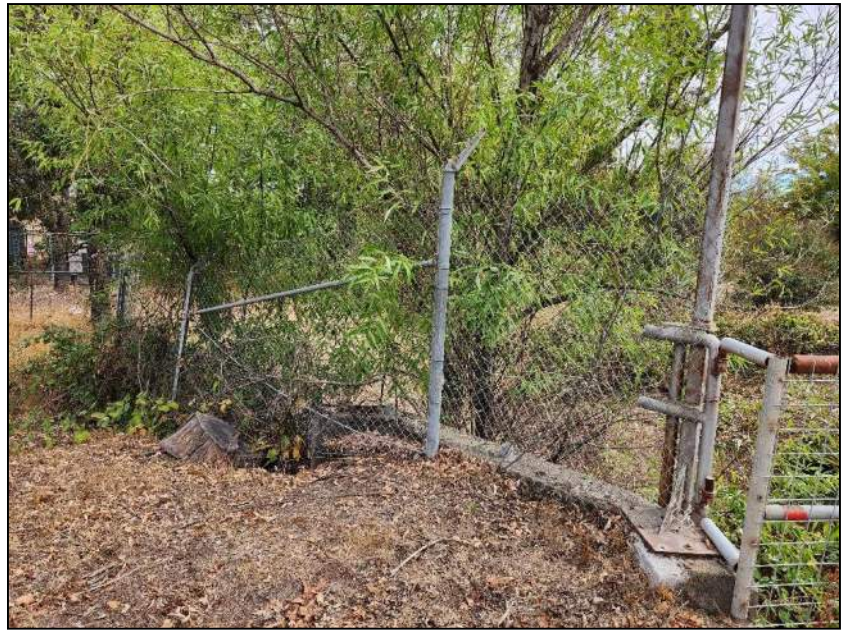
Fig 25: Sagging fence and gate post on Northeast side of bridge

Deck Elements	Rating				Remarks
					and poor connections of the posts to the bridge. The post on the west side of the bridge is not attached to the bridge.
Expansion Joints	G	F	P	N/A	The expansion joints have previously been paved over and the asphalt now has full depth cracks at the ends of the bridge. There is significant timber decking deterioration due to ongoing water ingress at these cracks.
Drainage System	G	F	P	N/A	No drainage system visible. The bridge deck is almost flat with inadequate slopes for drainage.
Lighting	G	F	P	N/A	No lighting.
Utilities	G	F	P	N/A	There is the one black cable beneath the bridge; please see "Superstructure Elements"
Fencing	G	F	P	N/A	North East abutment fence is sagging and pushed over. Please see figure 25

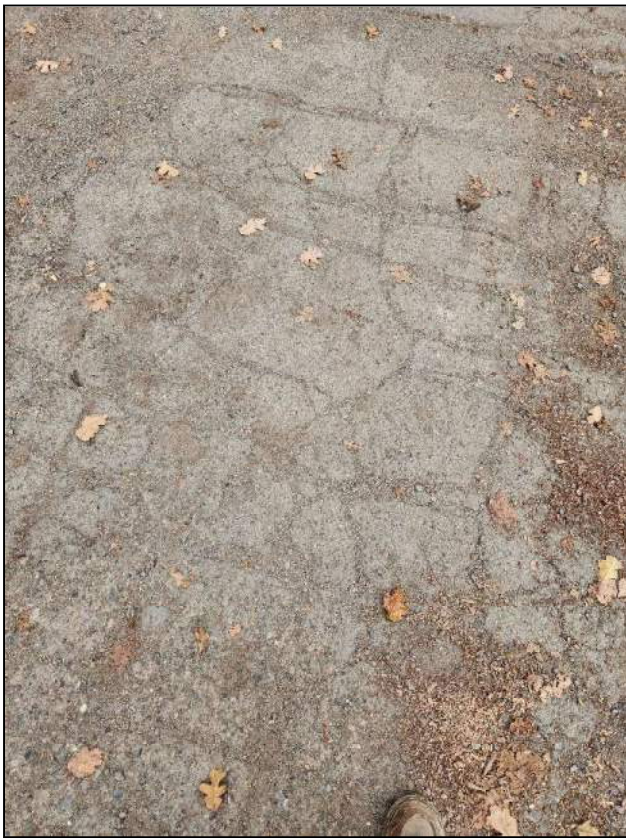
Fig 26: "Alligator" cracks at approach

<u>Approach Elements</u>	<u>Rating</u>				<u>Remarks</u>
Pavement Condition	G	F	P	N/A	There are "Alligator" cracks on the approach pavement. Please see figure 26 in Appendix B
Vertical Alignment (North Abut.)	G	F	P	N/A	
Horizontal Alignment (North Abut.)	G	F	P	N/A	
Vertical Alignment (South Abut.)	G	F	P	N/A	
Horizontal Alignment (South Abut.)	G	F	P	N/A

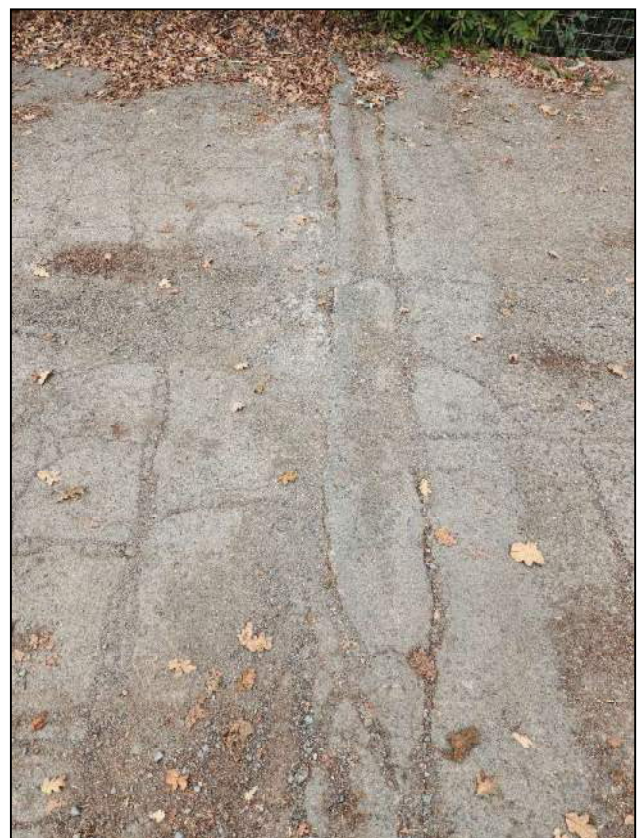
Fig 27: South abutment crack at expansion joint

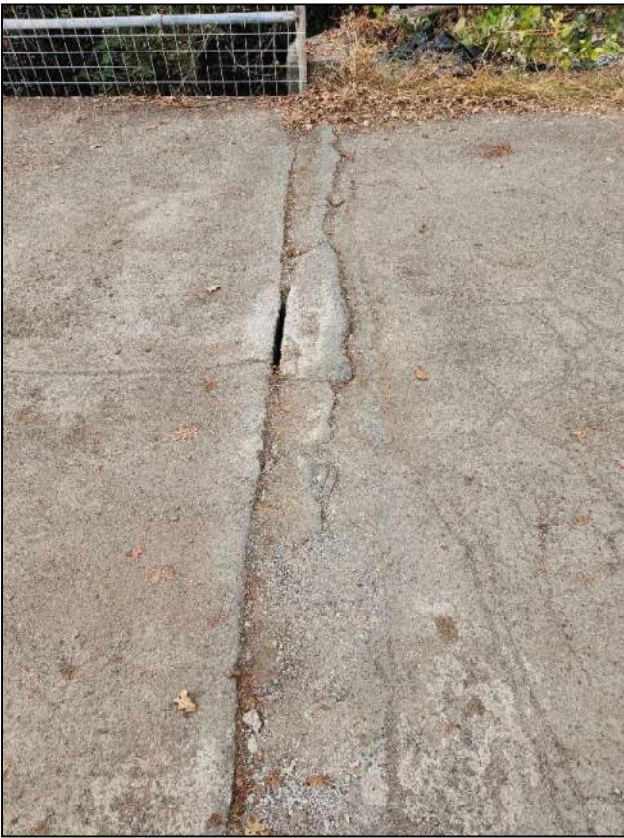
Fig 28: North abutment crack at expansion joint
