PRELIMINARY FINDINGS OF THE VISUAL ASSESSMENT

Pruitt Avenue Bridge Over Pruitt Creek

Prepared for Zero Waste Sonoma

November 2023

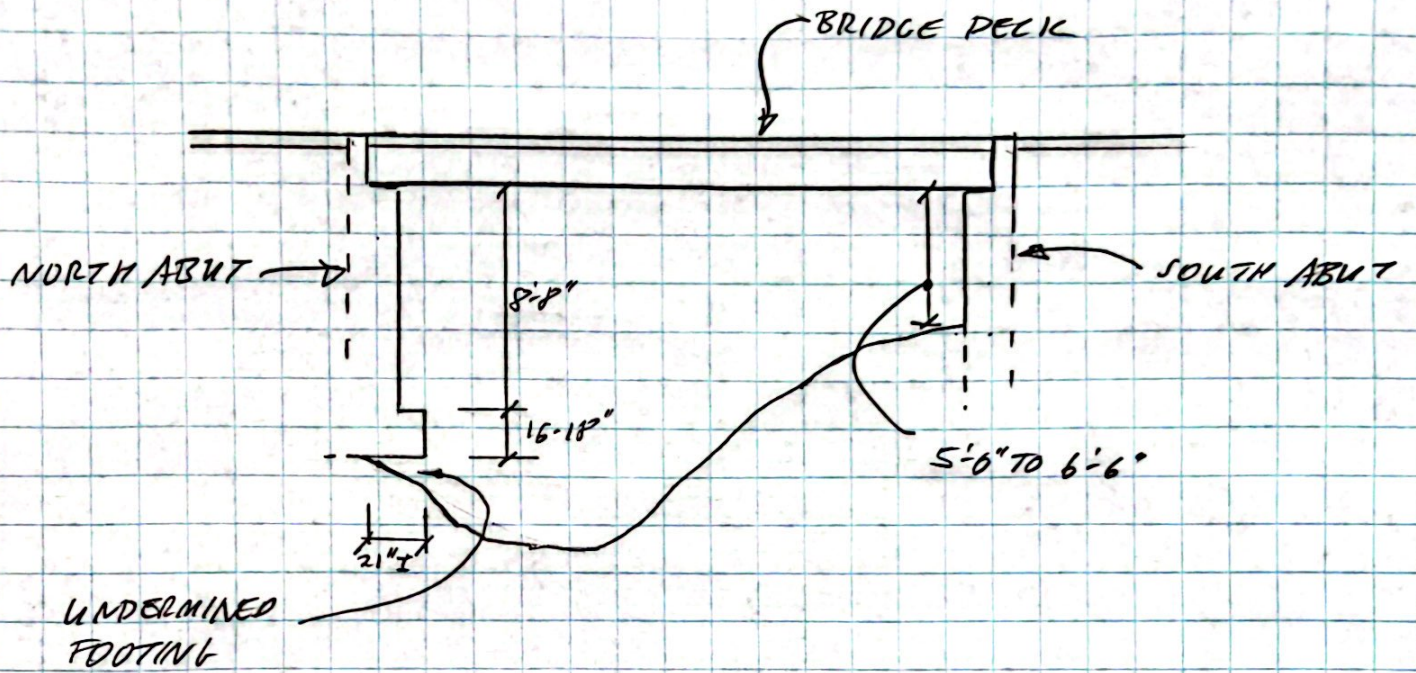
ELEVATION LOOKING EAST

The single span bridge is supported by two concrete abutments. Each abutment consists of a stemwall, two wingwalls, and a backwall. From our site visit, it appears the abutments are supported on spread footings. No piles were observed under the footing in areas of undermining. The stemwalls are 28'-10" wide and approximately 8'-8" tall based on the North abutment. The wingwalls are 8'-2" long and approximately 11.5" thick. The backwalls are the same width as the stemwall and 8" thick. The extents of the spread footing are unknown but is approximately 16"-18" thick and the same width as the stemwall. The seat of the abutment is approximately 10" wide.

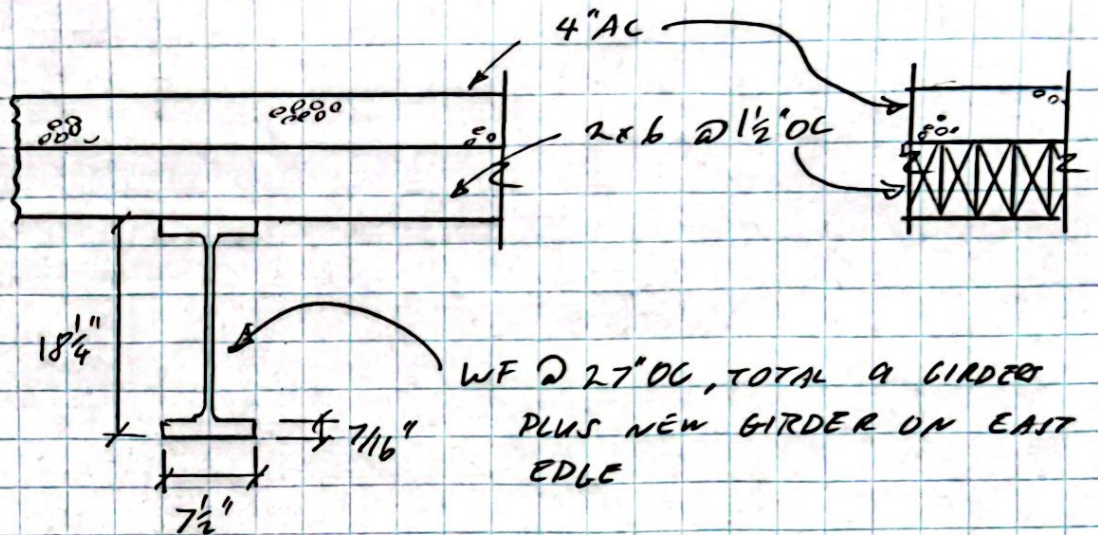
TYPICAL DECK SECTION

The main superstructure consists of (9) wide flange stringers that spans the total length of the bridge with timber decking laid transversely over the stringers. Asphalt was laid on top of this decking as a wearing surface. The top and bottom flanges of the stringers are 7.5" wide and 7/16" thick. The overall beam depth is 18". The stringers are spaced at approximately 27" on-center. There is a wide flange beam perpendicular to the main stringers near the midspan of the bridge bolted to the bottom flange of the stringers. In addition to the main stringers, an additional beam has been added to the outer East side of the bridge to become the new edge stringer for support of a railing replacement. This added beam consists of a wide flange beam with a steel channel welded to the top flange.. The stringers are supported directly on top of the abutment concrete seats.
